REPORT OF INVESTIGATION  
RED LODGE/BEARCREEK  
SUBSIDENCE POTENTIAL STUDY

October 30, 1987

Subject: Report of Investigation Red Lodge/Bearcreek  
Subsidence Potential Study  
Project No. 87-3001.D

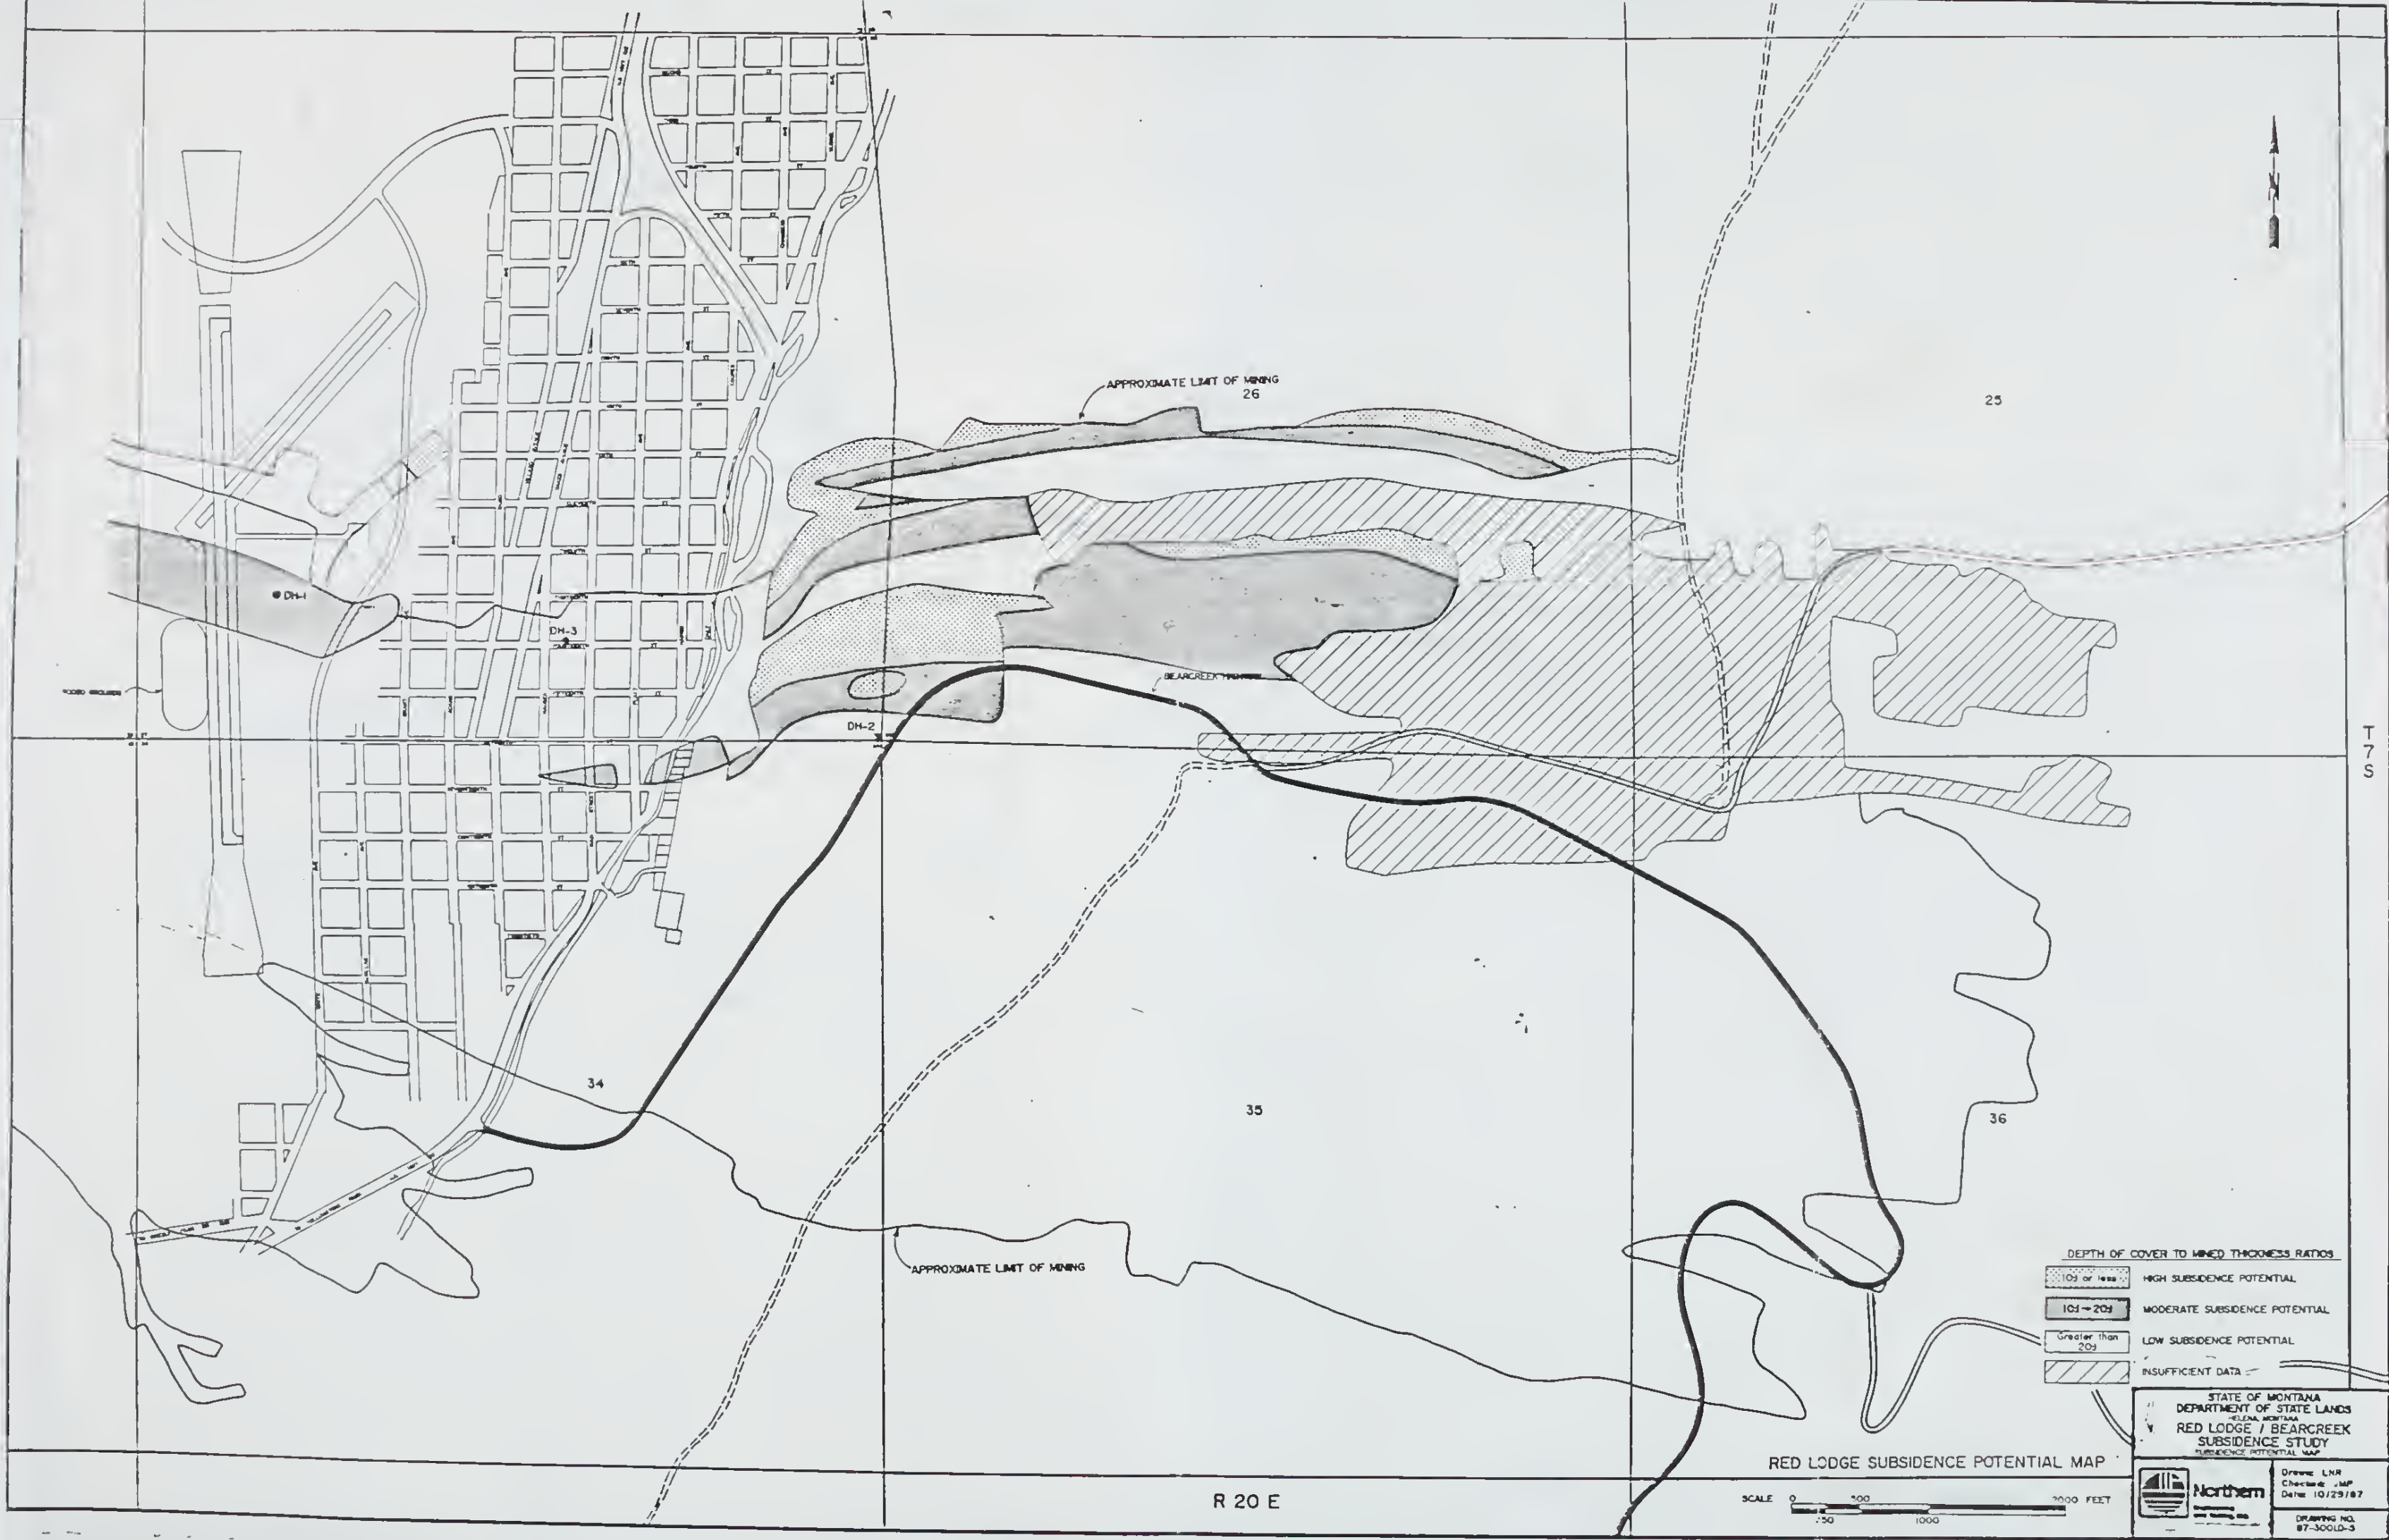
DRAWING NO.  
87-30310-6

DEPTH OF COVER TO MINED THICKNESS RATIOS

10:1 or less	HIGH SUBSIDENCE POTENTIAL
10:1 - 20:1	MODERATE SUBSIDENCE POTENTIAL
Greater than 20:1	LOW SUBSIDENCE POTENTIAL
Diagonal lines	INSUFFICIENT DATA

4. The potential for future subsidence is considered high only on the Bill Palmer property east of Red Lodge, near the west end of 10th Street, and above shallow adits in the Bearcreek area. It is predicted to consist of chimney subsidences similar to previous occurrences.
5. Two small areas within the town and part of the runway classify as having a moderate potential. The Red Lodge Subsidence Potential map is presented on page 12.
